NATIONS
Home Inspections & Energy Ratings

Home Inspection Report for:
Mr. and Mrs. Client
123 Main Street
Hometown, IL

123 Main Street, Hometown, IL

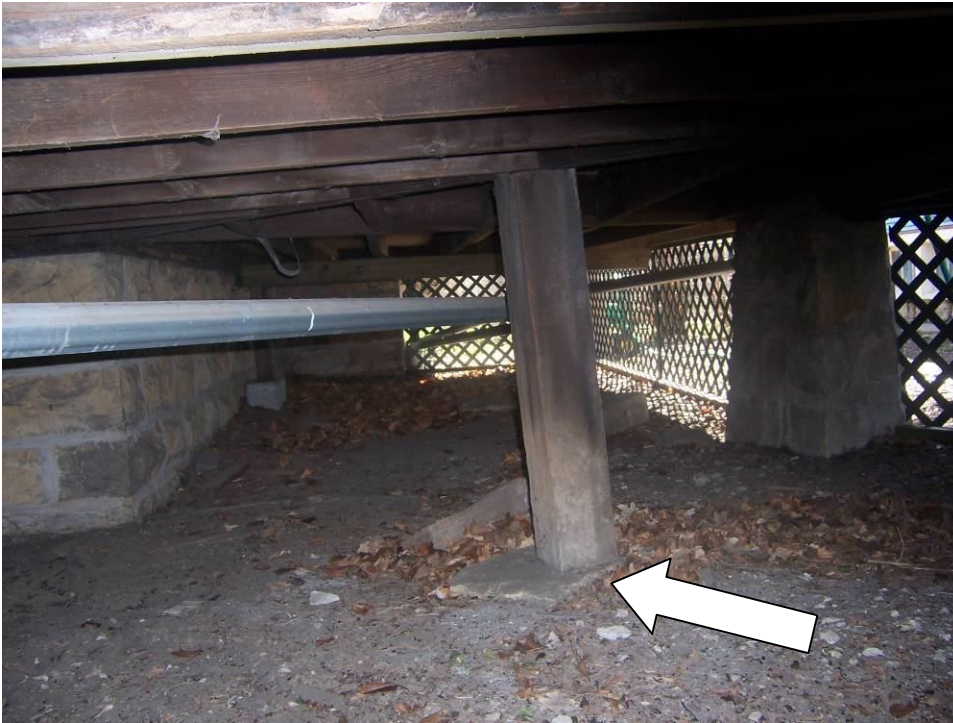
Front porch posts are poorly supported – they do not rest on a proper footing

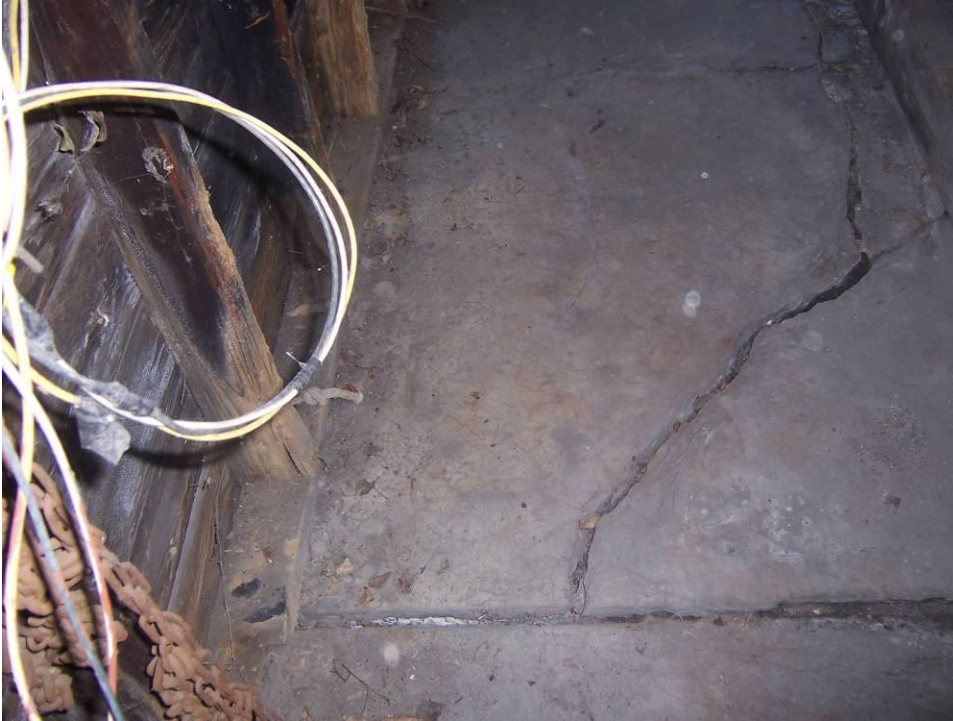
Garage slab and foundation have settled, and walls are not properly supported

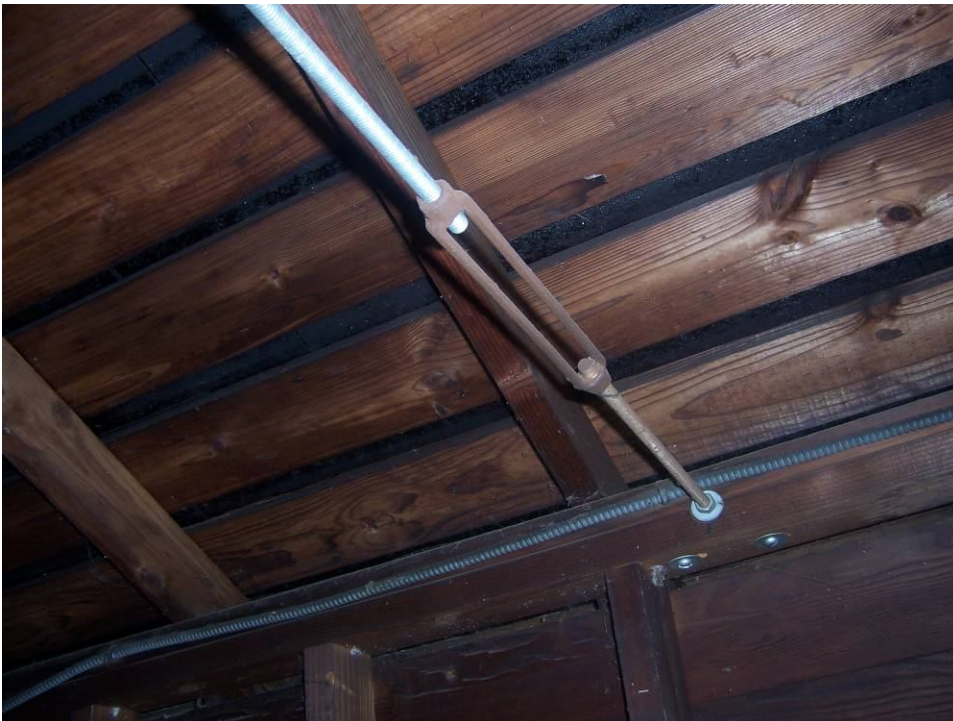
Steel rods have been added to support the garage walls – unsafe

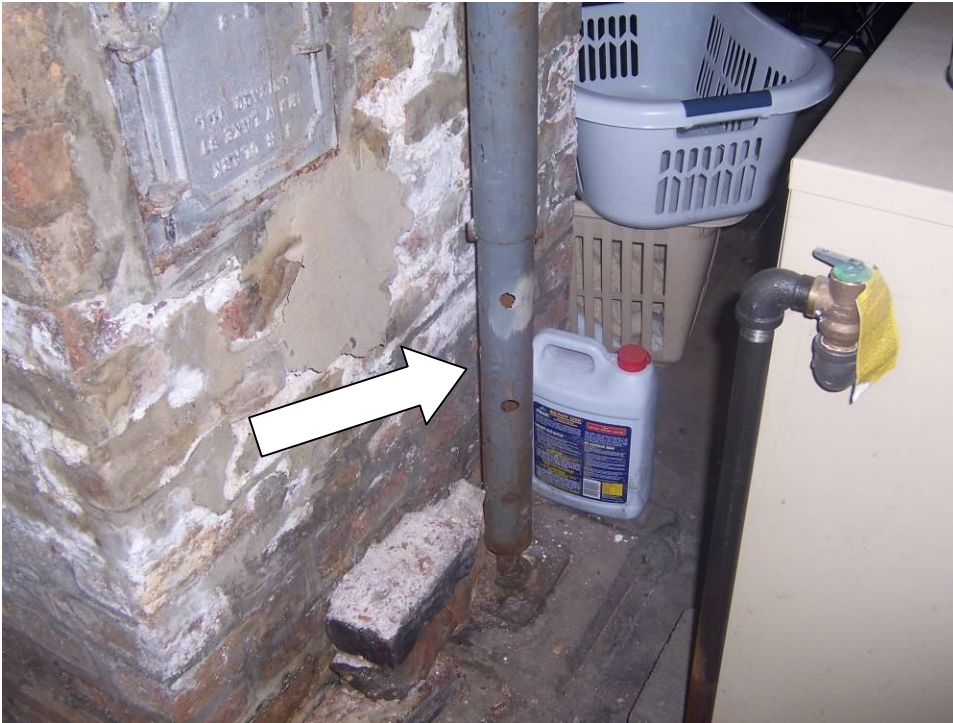
support post	replace	There is a support post in the basement near the chimney that is not designed or intended for permanent installation. Failure of this post would cause severe structural damage. Consult a well-qualified contractor to install a proper, permanent support post.	\$ 1,500-2,000
floor joist	repair	There is a floor joist that is notched excessively. This joist is incapable of carrying any significant load.	\$ 200-300

Support post in basement is not designed for permanent installation

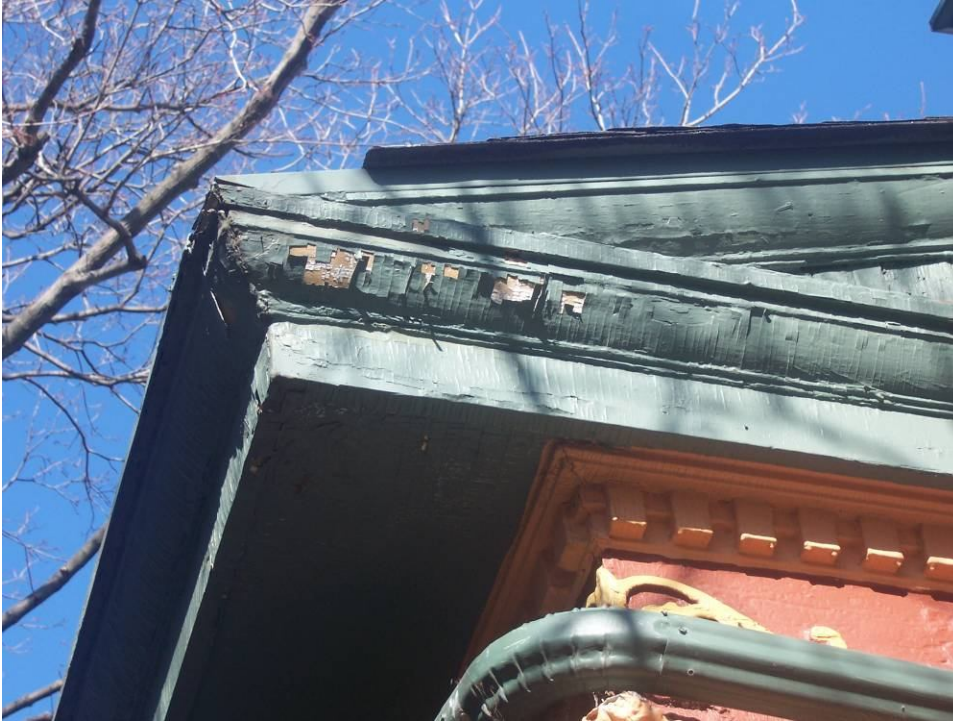
Peeling paint

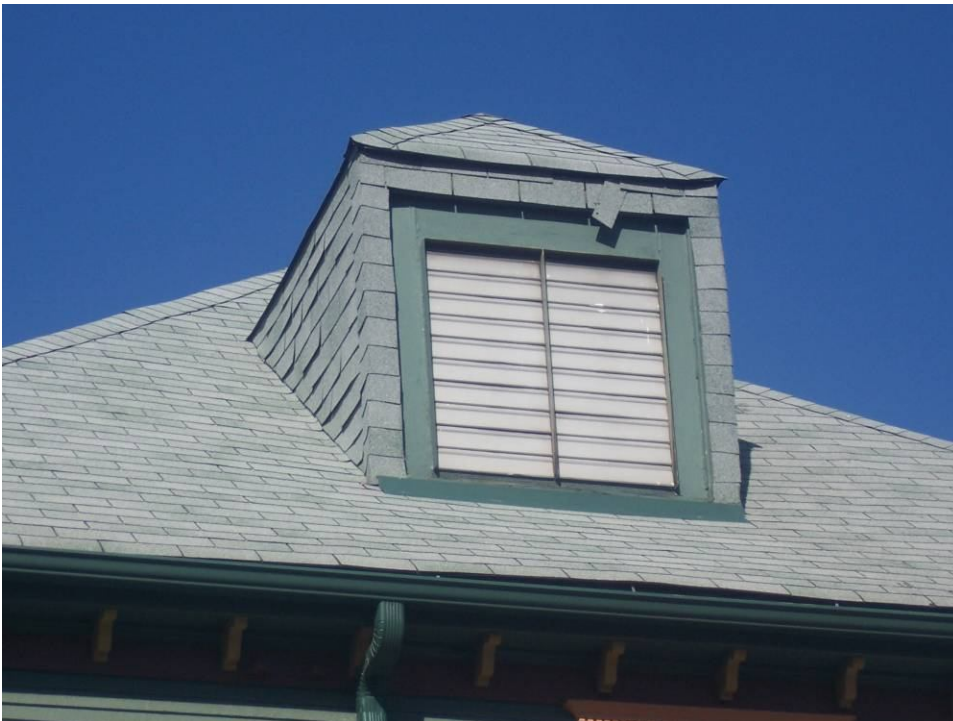
Asphalt shingles are not an appropriate siding material

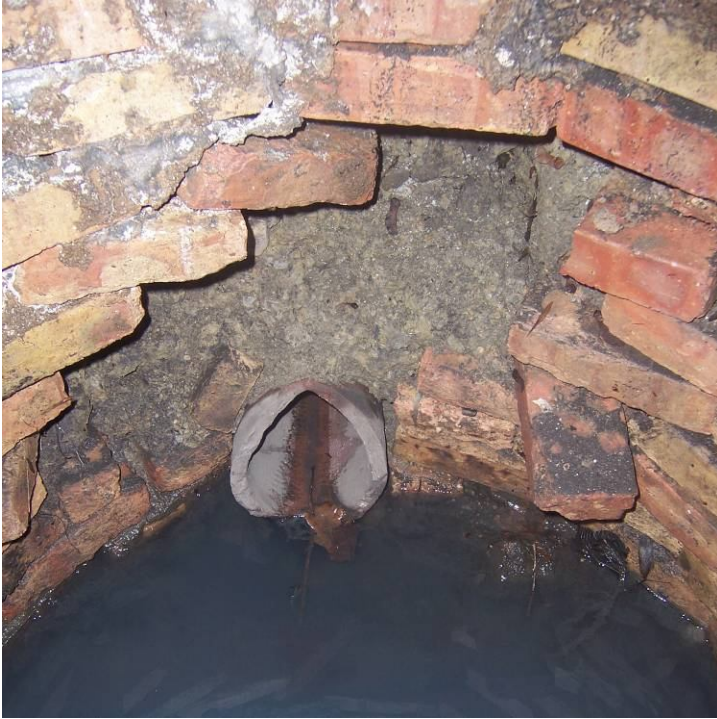
Item	Action	Deficiency	Budget
grease trap	repair	The structure of the grease trap is compromised. See picture. There are missing bricks. This can allow earth to collapse into the grease trap, causing clogs to the pipes and a sink hole in the ground above. Also, collapse of bricks into the grease trap may occur, again leading to blockage and further collapse of the ground above.	\$ 2,000-3,000
vent	repair	The vent pipe in the attic has an open line. This will allow sewer gases to enter the attic rather than be expelled to the outside.	\$ 100-200
shut off valves	repair	There are no handles for the shut off valves at the 2 nd floor bathroom. You should be able to quickly shut off the water without the use of any special tools.	\$ 50-100
freeze-vulnerable hose spigot	maintenance or replace	The exterior hose spigots are freeze-vulnerable. They must be shut off during the winter to prevent freezing. Or they can be replaced with frost-proof type that does not require shut off in the winter.	\$ 200-300 for replacement

Bricks missing at grease trap – structure may collapse

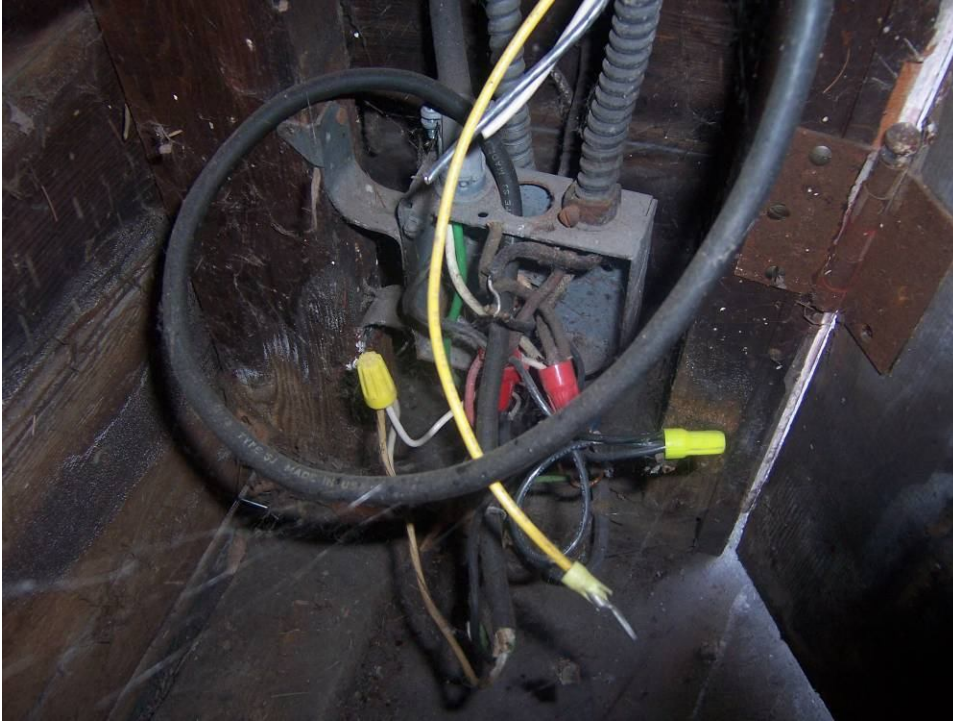
Item	Action	Deficiency	Budget
garage wiring	repair/replace	All of the electrical wiring in the garage is sub-standard and is unsafe. There are exposed wires that are not protected in any way. There are electrical splices that are hanging out of the electrical box. There is extension cord wiring used to provide power to the exterior light. This is unsafe. Have a licensed electrician make the required repairs.	\$ 400-800
electrical box, 2 nd floor	replace	There are electrical splices made in a box at the 2 nd floor. This older box is not an approved electrical box. This is unsafe. Have a well-qualified licensed electrician install a proper listed electrical box.	\$ 300-500
GFCI electrical receptacles	replace	There are receptacles in the house that are not Ground Fault Circuit Interrupter (GFCI) protected. This is unsafe. According to the <i>International Residential Code</i> section 3802, all receptacles at the following locations require GFCI protection: exterior, serving kitchen countertops, all bathrooms, garage, unfinished basements. Install GFCI receptacles as required. See especially the kitchen, the garage, the exterior at the front porch.	\$ 200-300

Garage wiring is unsafe - exposed wires

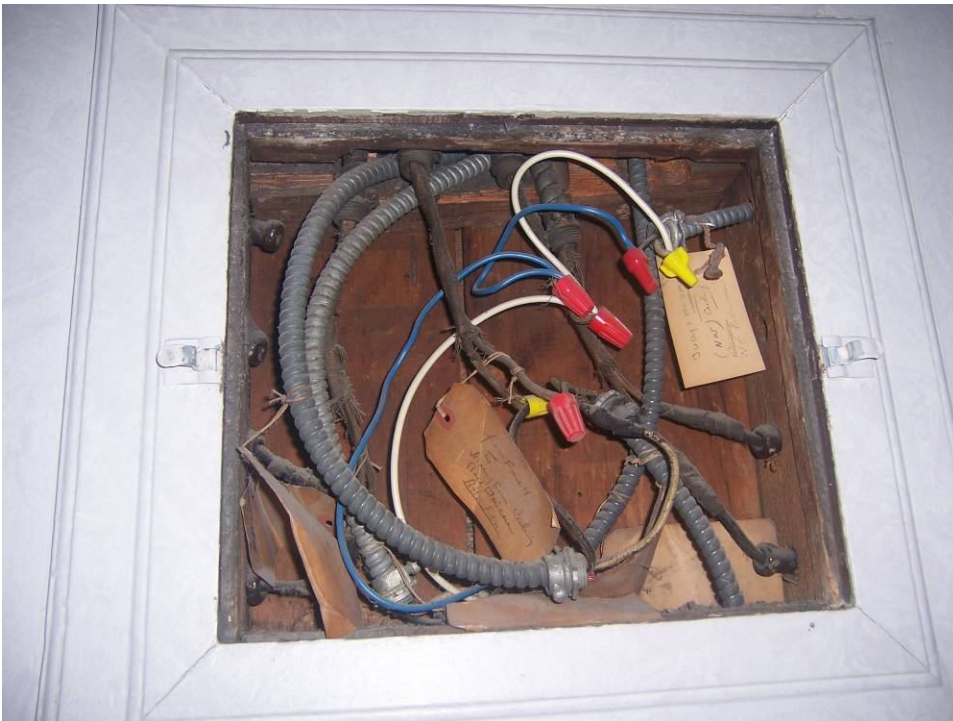
Electrical splices are not made inside an approved box
