**NATIONS**  
*Home Inspections  
& Energy Ratings*

March 19, 2011

**Home Inspection Report for:**

123 Main Street

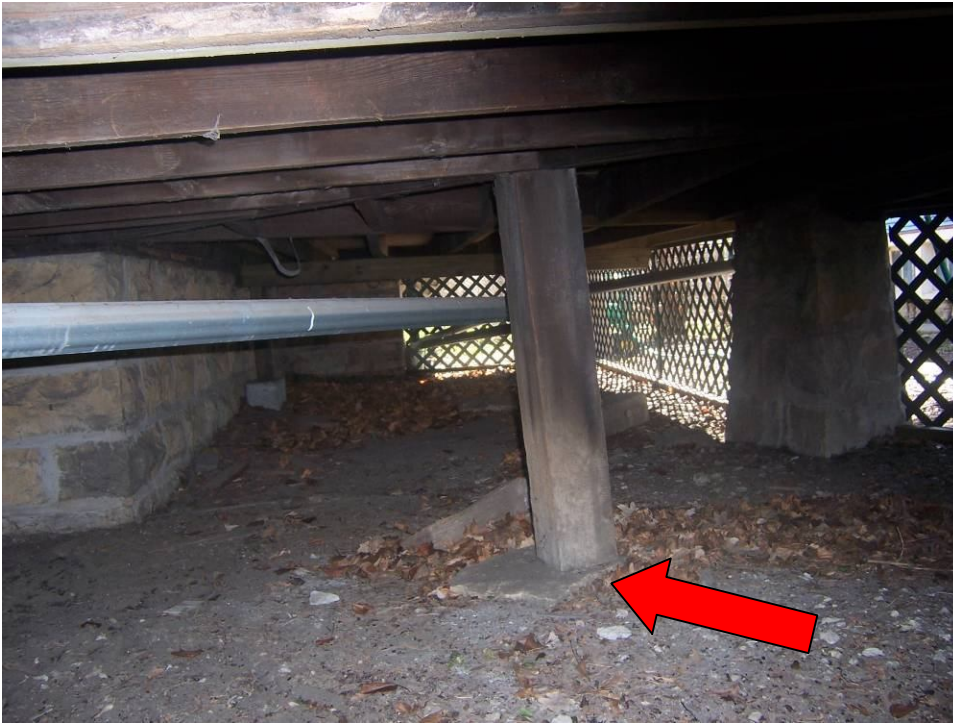
Item	Action	Deficiency	Budget
Front porch supports	repair	Several of the support posts at the front porch are not well supported on the ground. See picture. Several of the posts appear to be bearing only on a piece of flagstone laid on the ground. All such support posts should bear on a footing that extends below the frost line. Failure to properly support these posts can lead to settling or frost heaving, or both.	\$ 1,000-2,000
rear deck	repair	The rear deck is poorly supported at the house. The main support beams do not appear to be properly attached to the house structure. This is unsafe. Make repairs as required. It appears that the deck can be left in place and additional support added.	\$ 600-1,000
garage	repair/ replace	The garage slab/foundation has settled, especially at the west side. The walls, especially the west wall, are not properly supported and are leaning due to the settling of the slab. Supplemental supports in the form of steel rods have been added to help support the walls. The garage structure is unsafe. Replace the garage.	\$ 10,000-15,000+

**Front porch posts are poorly supported – they do not rest on a proper footing**

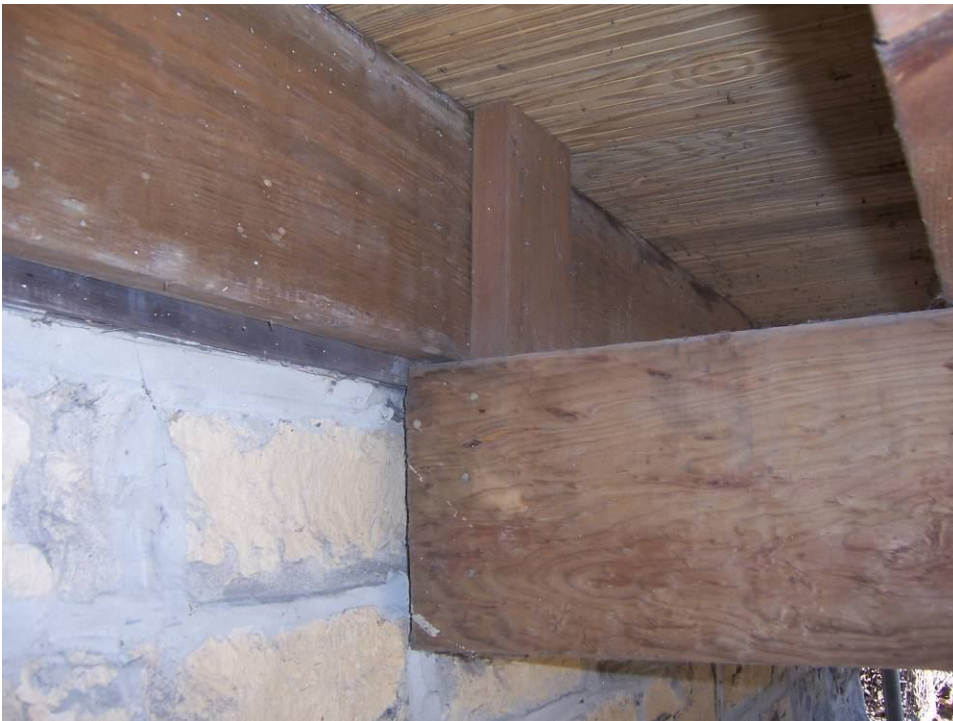
**Rear deck is poorly supported at the house**

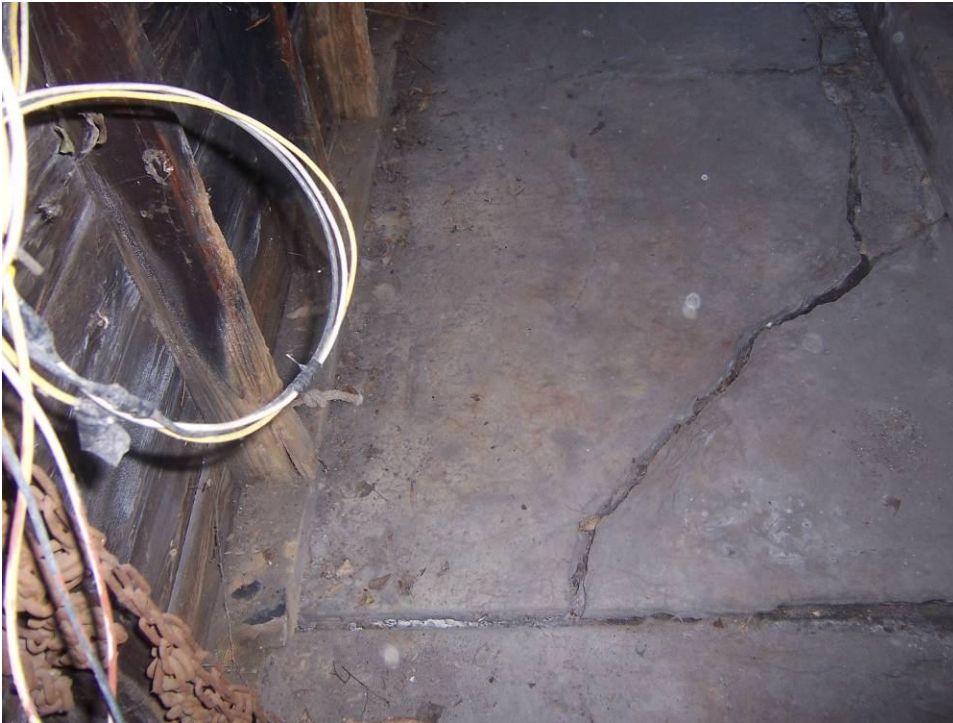
**Garage slab and foundation have settled, and walls are not properly supported**

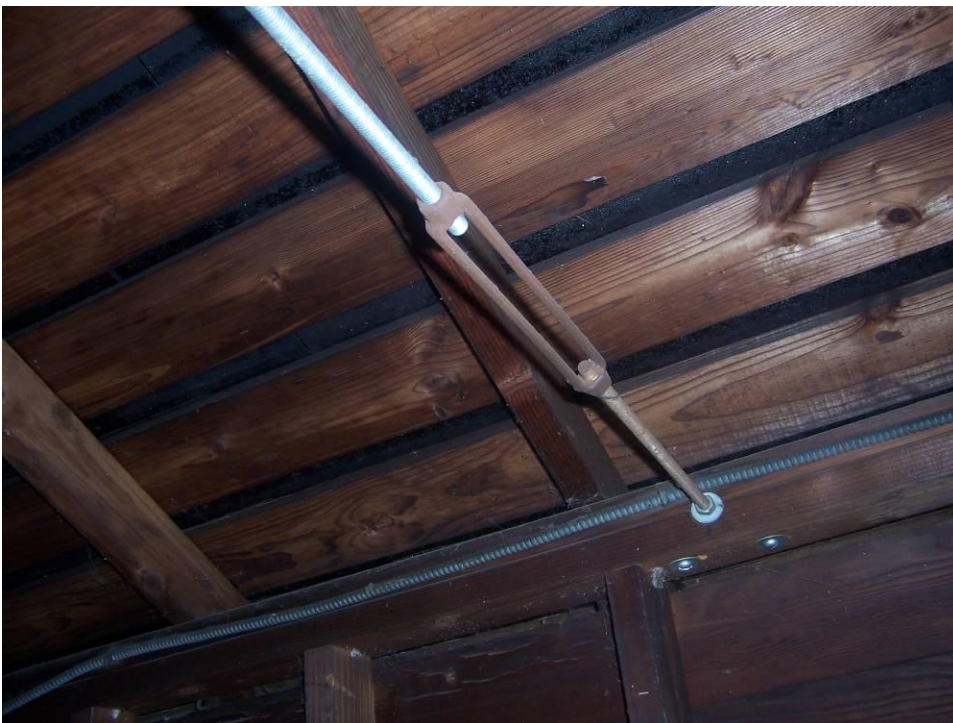
**Steel rods have been added to support the garage walls – unsafe**

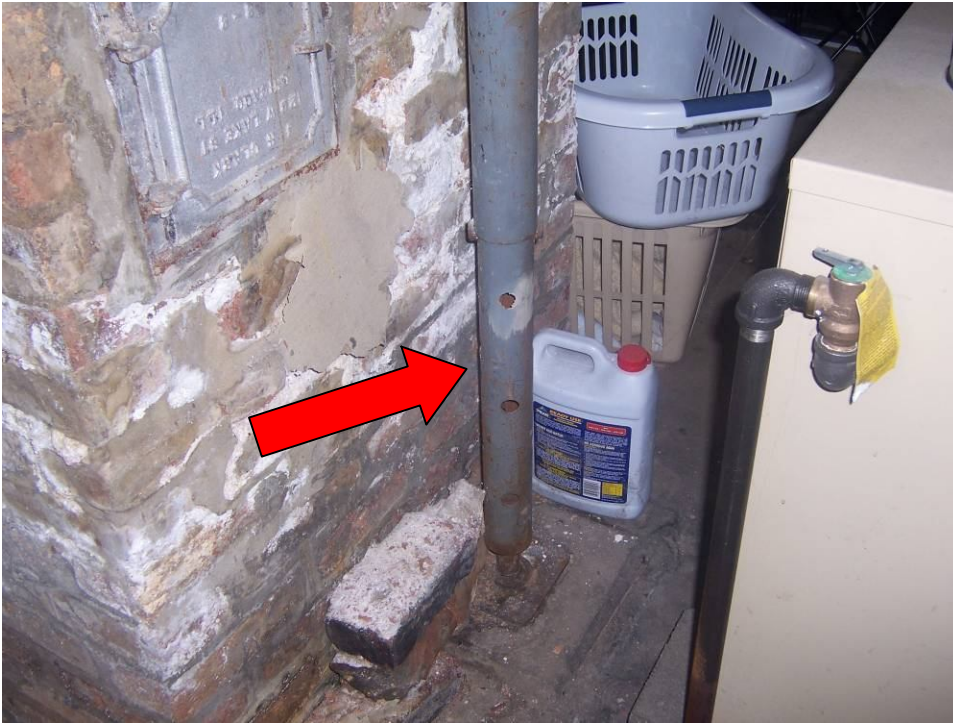
support post	replace	There is a support post in the basement near the chimney that is not designed or intended for permanent installation. Failure of this post would cause severe structural damage. Consult a well-qualified contractor to install a proper, permanent support post.	\$ 1,500-2,000
floor joist	repair	There is a floor joist that is notched excessively. This joist is incapable of carrying any significant load.	\$ 200-300

**Support post in basement is not designed for permanent installation**

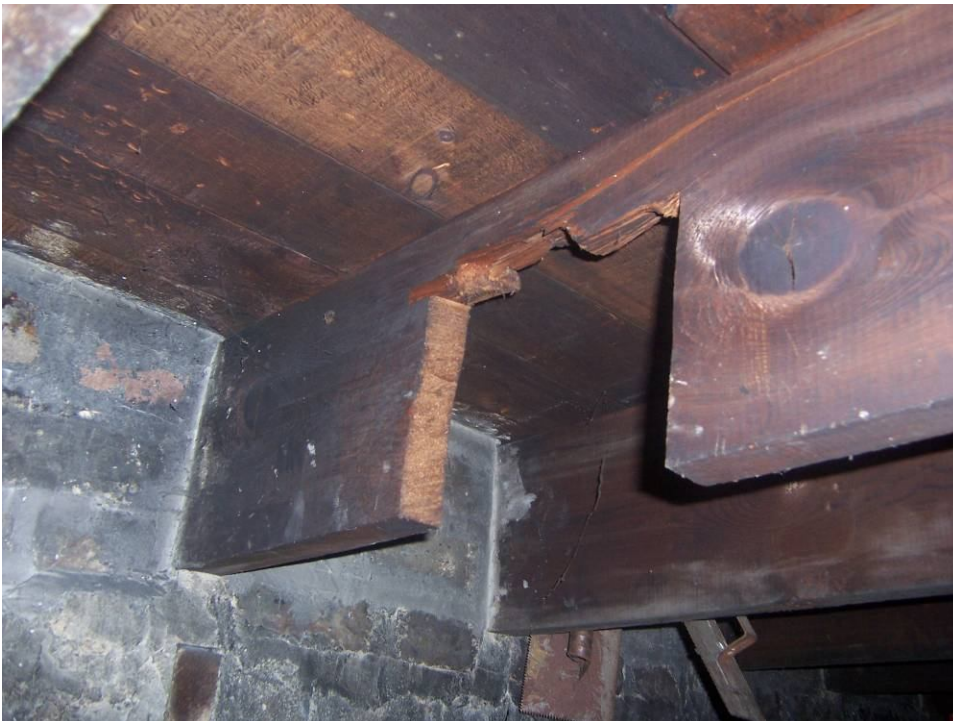
**Floor joist has been notched excessively**

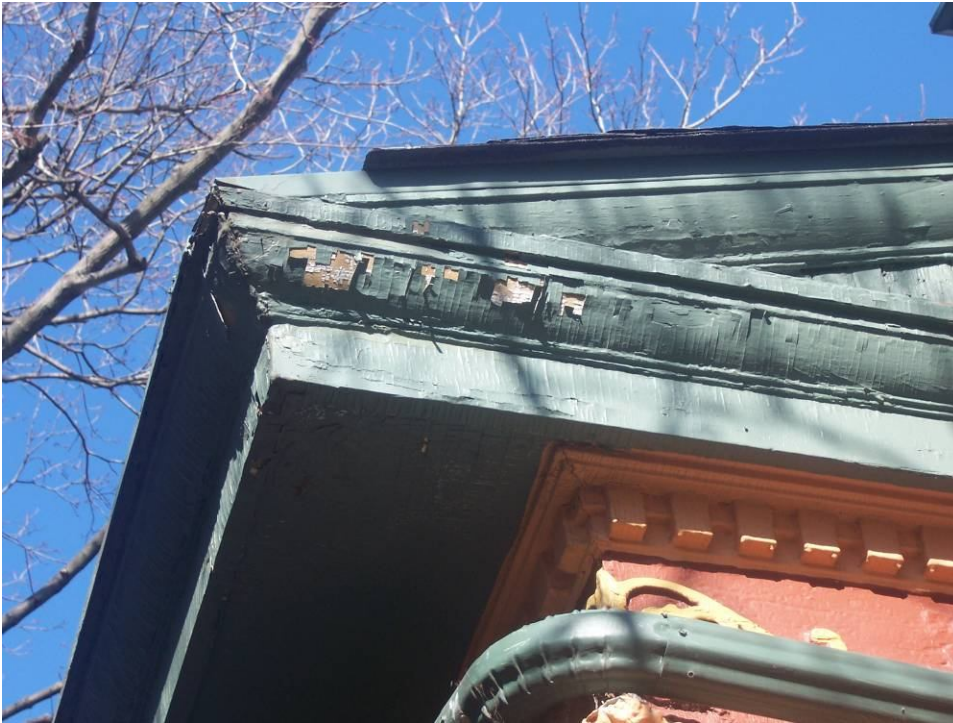
Item	Action	Deficiency	Budget
siding and trim	paint	There is peeling paint at several locations at the exterior. Exterior paint generally lasts no more than 5-10 years at best. Paint is not only decorative but also helps to protect the wood it covers from rot and decay.	\$ 10,000-20,000+
dormer siding	repair/replace	Asphalt shingles are used as siding material at the dormer. Asphalt shingles are not appropriate as siding material. Asphalt shingles are designed to seal to the shingle below, which cannot happen if the shingles are held vertically.	\$ 800-1,200
tree limbs	trim	There are tree branches that overhang the house. This is unsafe. A falling branch can do considerable damage to the house. The branches should be trimmed back. Typically, a homeowner has the right to trim branches that overhang his/her property regardless of whose property the tree is on.	\$ 800-1,200
fence gate	repair	The fence gate at the south side has come off its hinges.

**Peeling paint**

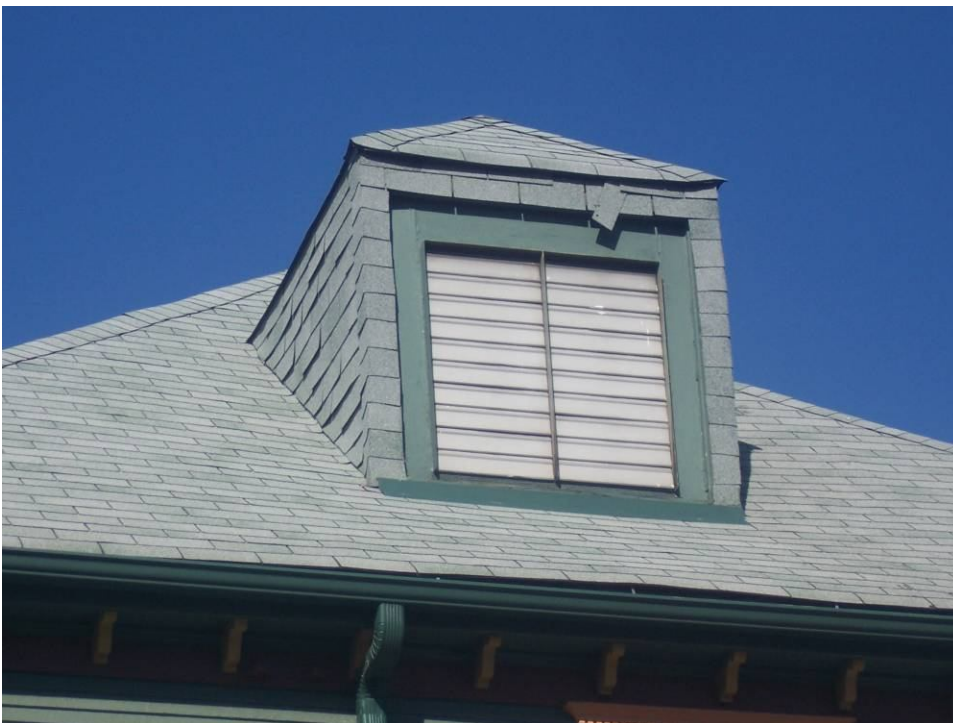
**Asphalt shingles are not an appropriate siding material**

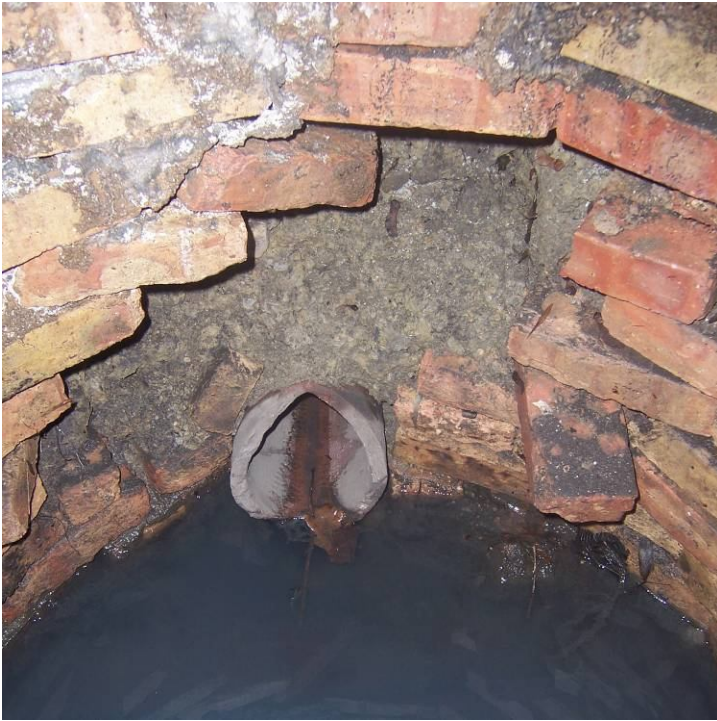
Item	Action	Deficiency	Budget
grease trap	repair	The structure of the grease trap is compromised. See picture. There are missing bricks. This can allow earth to collapse into the grease trap, causing clogs to the pipes and a sink hole in the ground above. Also, collapse of bricks into the grease trap may occur, again leading to blockage and further collapse of the ground above.	\$ 2,000-3,000
vent	repair	The vent pipe in the attic has an open line. This will allow sewer gases to enter the attic rather than be expelled to the outside.	\$ 100-200
shut off valves	repair	There are no handles for the shut off valves at the 2 <sup>nd</sup> floor bathroom. You should be able to quickly shut off the water without the use of any special tools.	\$ 50-100
freeze-vulnerable hose spigot	maintenance or replace	The exterior hose spigots are freeze-vulnerable. They must be shut off during the winter to prevent freezing. Or they can be replaced with frost-proof type that does not require shut off in the winter.	\$ 200-300 for replacement

**Bricks missing at grease trap – structure may collapse**

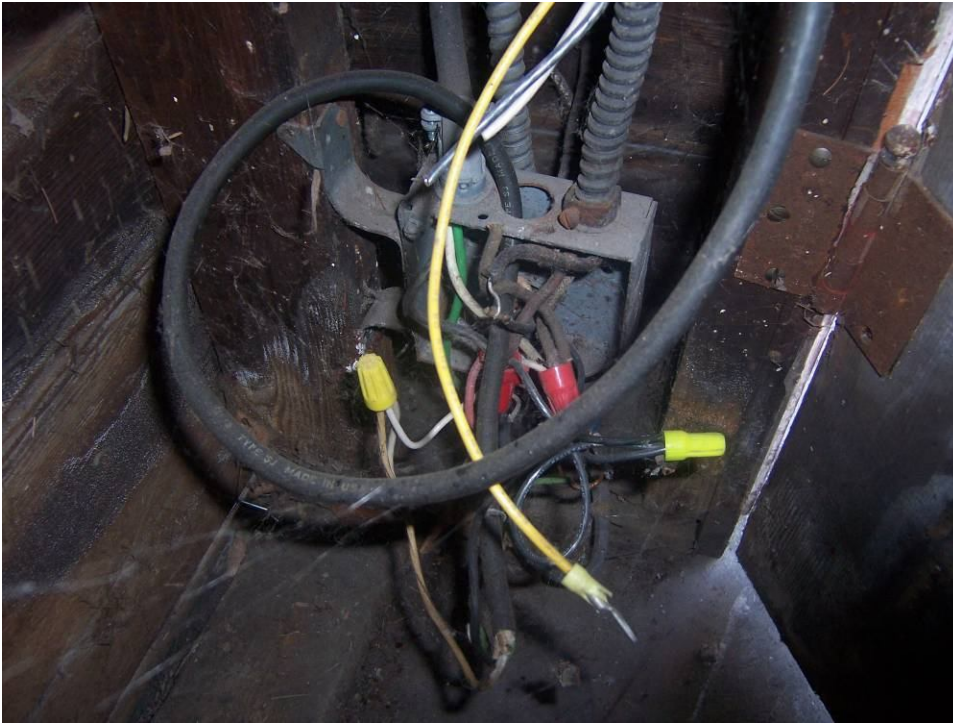
Item	Action	Deficiency	Budget
garage wiring	repair/replace	All of the electrical wiring in the garage is sub-standard and is unsafe. There are exposed wires that are not protected in any way. There are electrical splices that are hanging out of the electrical box. There is extension cord wiring used to provide power to the exterior light. This is unsafe. Have a licensed electrician make the required repairs.	\$ 400-800
electrical box, 2 <sup>nd</sup> floor	replace	There are electrical splices made in a box at the 2 <sup>nd</sup> floor. This older box is not an approved electrical box. This is unsafe. Have a well-qualified licensed electrician install a proper listed electrical box.	\$ 300-500
GFCI electrical receptacles	replace	There are electrical receptacles that are not Ground Fault Circuit Interrupter (GFCI) protected as required. This is unsafe. According to the <i>International Residential Code</i> section 3802, GFCI receptacles are required at these locations: <ul style="list-style-type: none"> <li>• all bathroom receptacles,</li> <li>• all receptacles serving kitchen countertops,</li> <li>• all wet bar countertop receptacles within 6 feet of a sink,</li> <li>• all outdoor receptacles,</li> <li>• all receptacles in garages and unfinished basements.</li> </ul> See especially the kitchen, the garage, the exterior at the front porch.	\$ 200-300

**Garage wiring is unsafe - exposed wires**

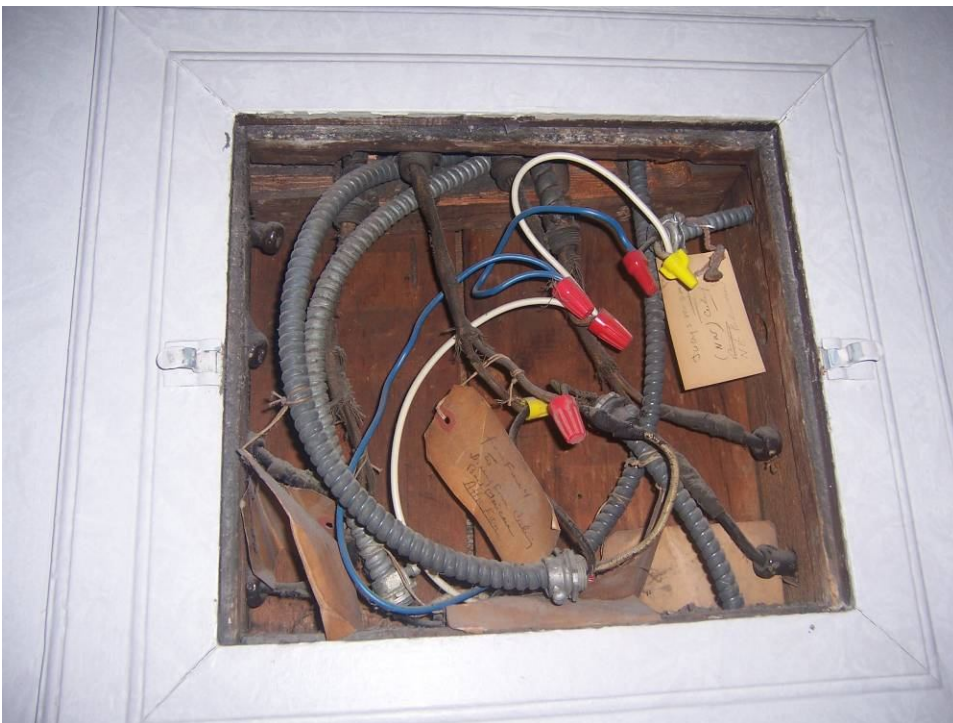
**Electrical splices are not made inside an approved box**

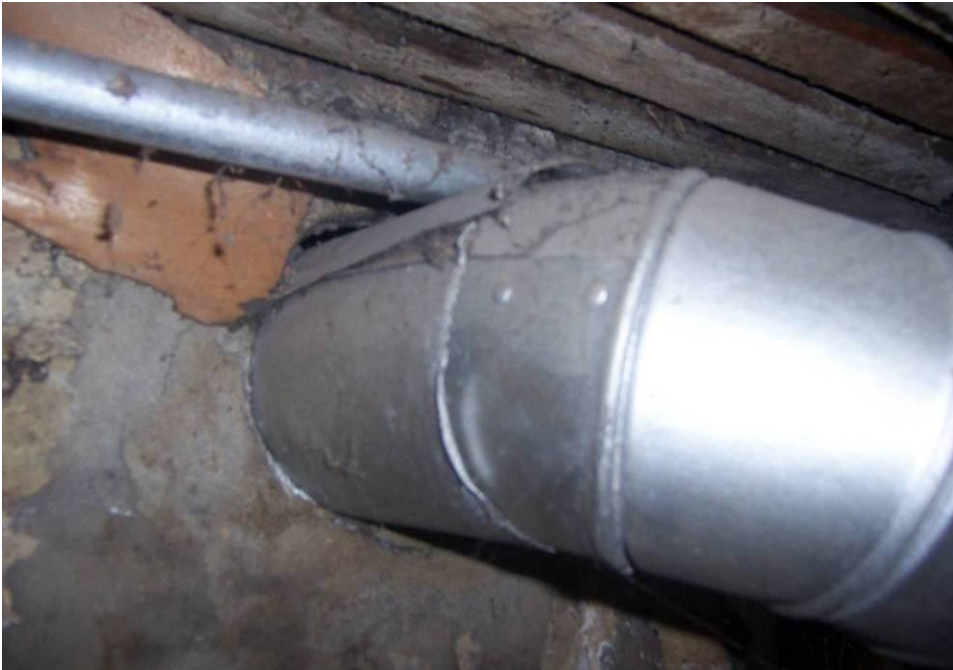
<b>Item</b>	<b>Action</b>	<b>Deficiency</b>	<b>Budget</b>
water heater flue	repair	The water heater flue is poorly installed. There are joints in the flue that are not properly connected with screws or other mechanical fasteners. The flue is not well sealed into the chimney. The flue is unsafe.	\$ 200-300
boiler flue	repair	The boiler flue goes through a green box before it enters the chimney. This green box may be a remnant of an old type of draft hood which is antiquated technology and no longer should be used. It cannot be determined during a visual inspection to determine if the newer boiler flue goes directly through this green box and into the chimney. If the flue does not go through the green box, if the box is part of the flue system, then the flue is unsafe. Old, unused components should be removed as they are taken out of service. Have a well-qualified HVAC contractor confirm that the boiler flue is installed properly.	\$ 200-400

**Water heater flue is poorly installed - unsafe**

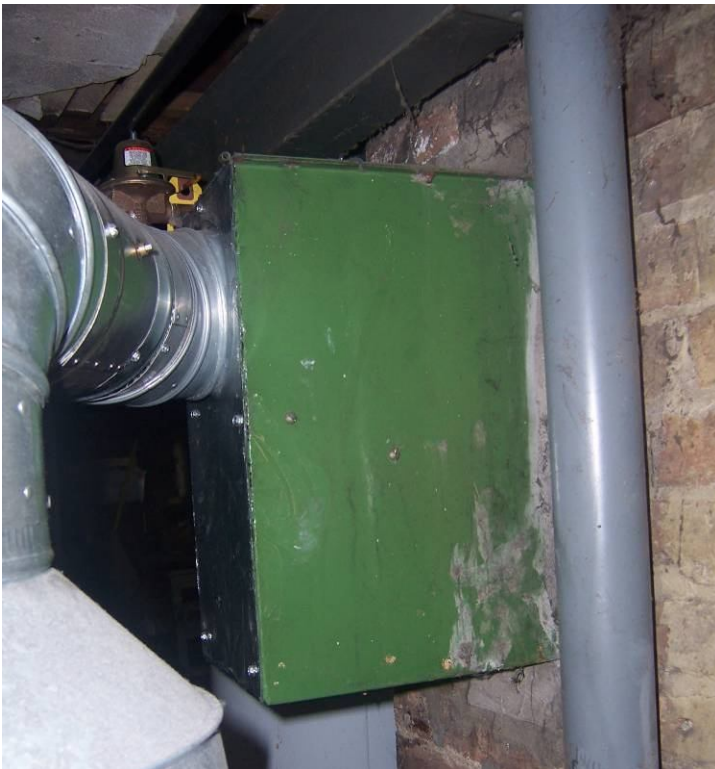
**The boiler flue should enter directly into the chimney – the green box should be removed**
